Wood Floor Restoration Summary
Patterson House – Washington, DC
Summer 2006

Rosebud Co.
Atlanta, Ga.

Overview and Explanation

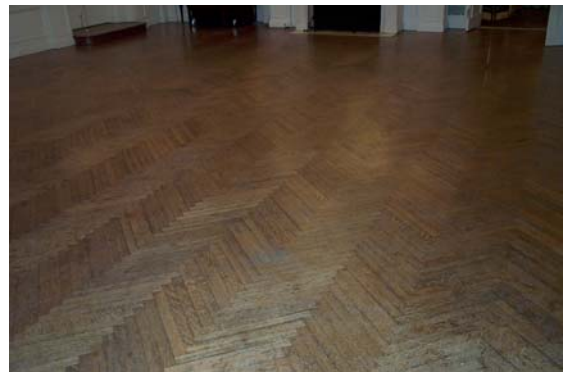
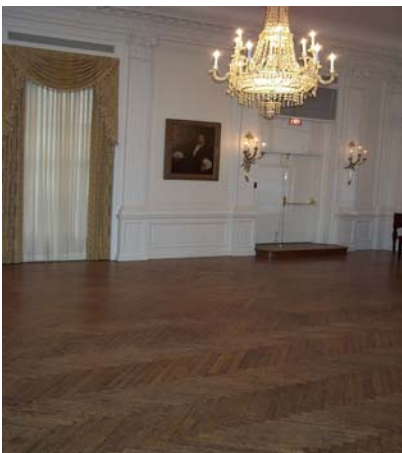
The primary concern in the ballroom area was the overall condition of the floors and their appearance. Due to their age, the floors had experienced multiple sanding and substantial loss of original material. The erosion of the wood was exacerbated due the herringbone pattern. Due to this pattern much of the sanding of the floors would have

been against the grain of the wood and this would have accelerated the loss of the oak flooring. It would be safe to say the floors had been sanded a minimum of three to four times during its history and the amount of wood lost was beginning to show in structural failure along the tongue and groove of the wood. The wood was too thin to adequately support weight and was fracturing or shearing along the parallel seams of the wood.

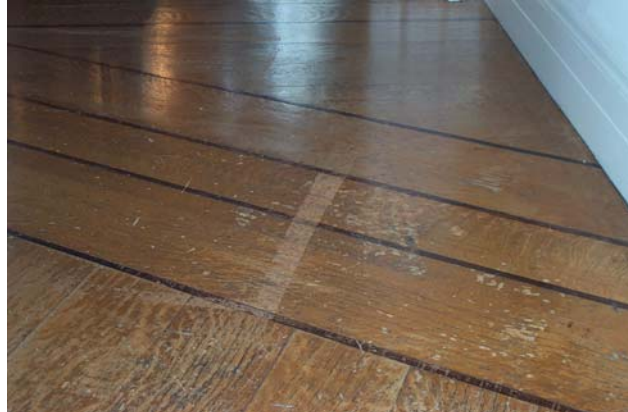
During the visit, attention was also focused on the second floor foyer and the Patterson Dining Room. Of particular concern in the foyer was the damage that had occurred from caterers by applying adhesive tape to the older finish. When the tape was removed, layers of old finish were pulled up leaving clear and visible evidence of the damage.

This damage was not only visible but also added one more distraction to a floor that had been intended to be a beautiful and decorative background and compliment the interior décor of this magnificent home.

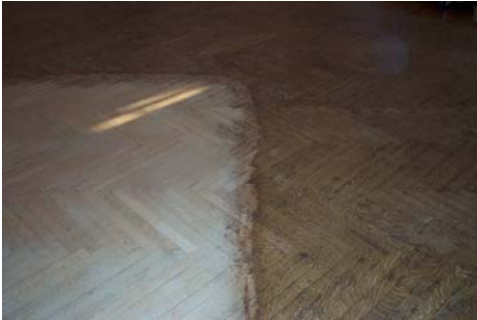
This sequence shows the ballroom floors in the “during” phase. Note the grey color of the old finish against the stark white of the oak.

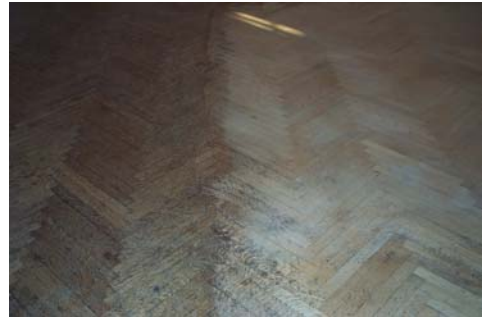
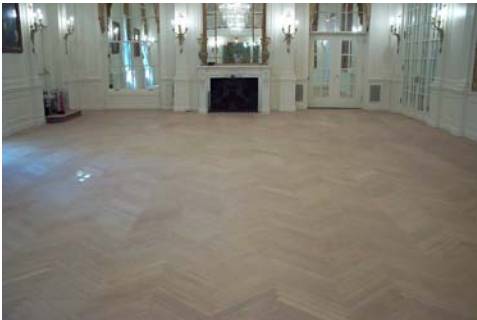
On the left, the ballroom floors have been completely stripped. On the right, the Danish Oil is being buffed into the wood.

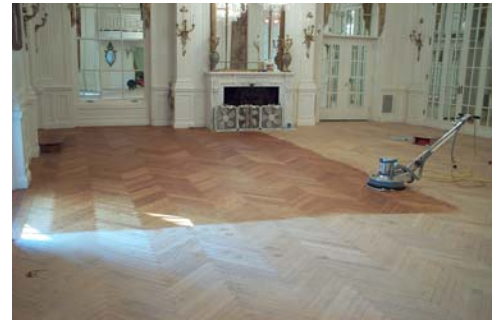
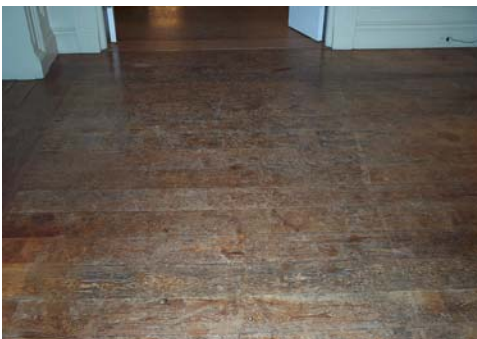
Before pictures of the pine floors in the Patterson Dining Room. Note lack of color and definition of distinguishing graining pattern.

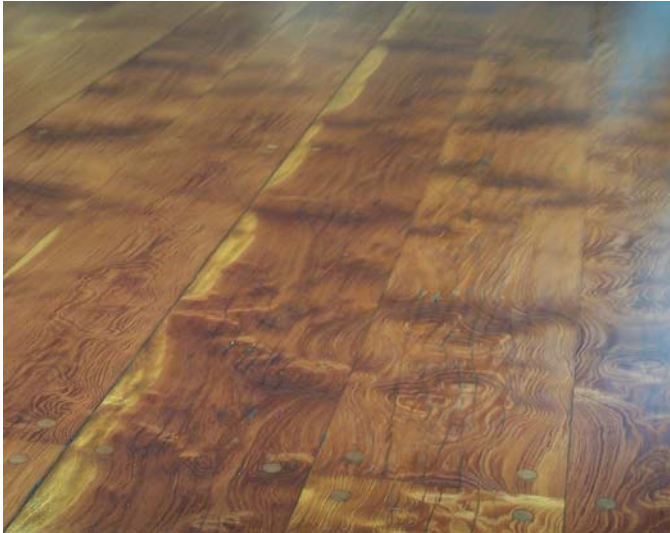
Here we see the distinctive graining patterns of the yellow pine in the dining room after the restoration was completed. The burl'd texture of the wood is very unique and would have required considerable time and effort in the selection and installation process. In checking with suppliers of replacement materials it is obvious that this would be a very difficult floor to duplicate today. The wood is a veneer over an oak backing. This is the finest example of burl'd aged yellow pine I have ever seen.

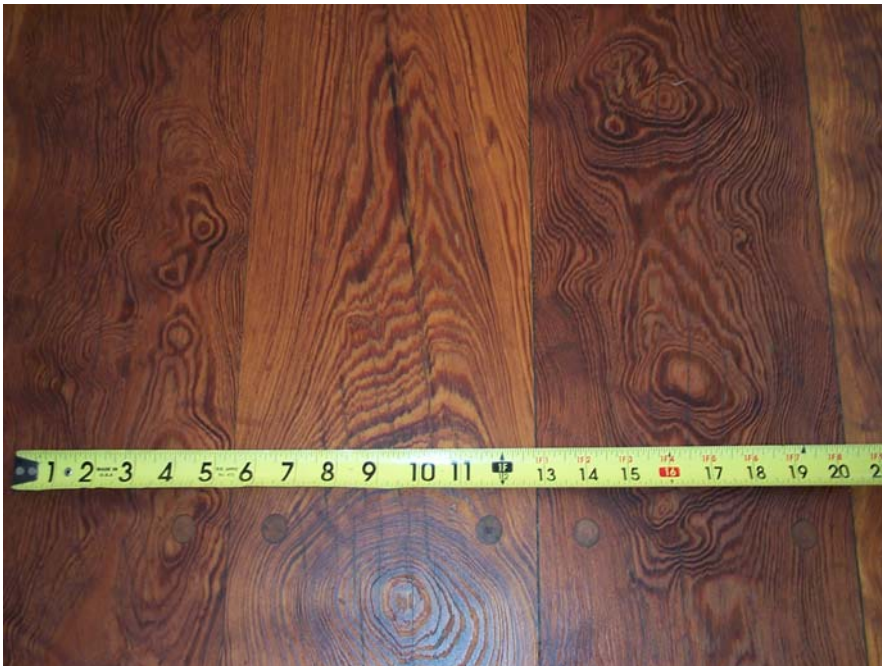
A more direct photo of the floor shows the rich and detailed color of the pine as well as its dimensions. Although the overall condition of the wood in this room was good, it is at risk from the high heels of women's shoes and rolling the tables into the rooms on their sides. Care must be taken to prevent further damage.

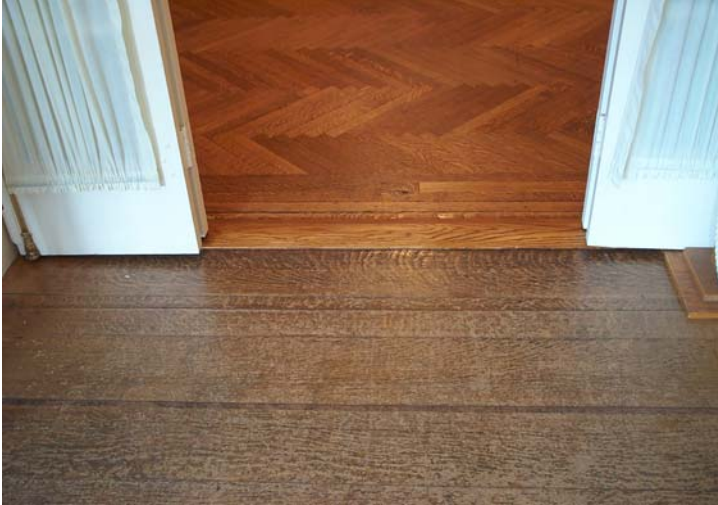
This photo shows the contrast in the old finish, in the foreground, compared to the restored floors in the background. This photo was shot at the entrance to the ballroom through the French doors from the foyer. The flooring in the foreground shows the foyer prior to its restoration against the freshly restored wood floors in the ballroom. The color variation is almost totally due to the color deterioration of the older finish.

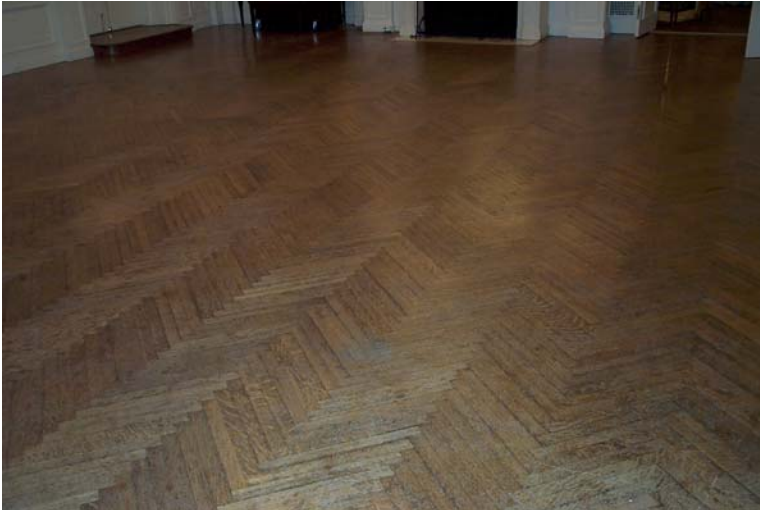
Here we are able to see the condition of the ballroom floor before the start of the restoration work. The aged finish gave the floors a dull grey color that also blocked the color of the natural wood. It was also prone to chipping and cracking due to the use it was exposed to.

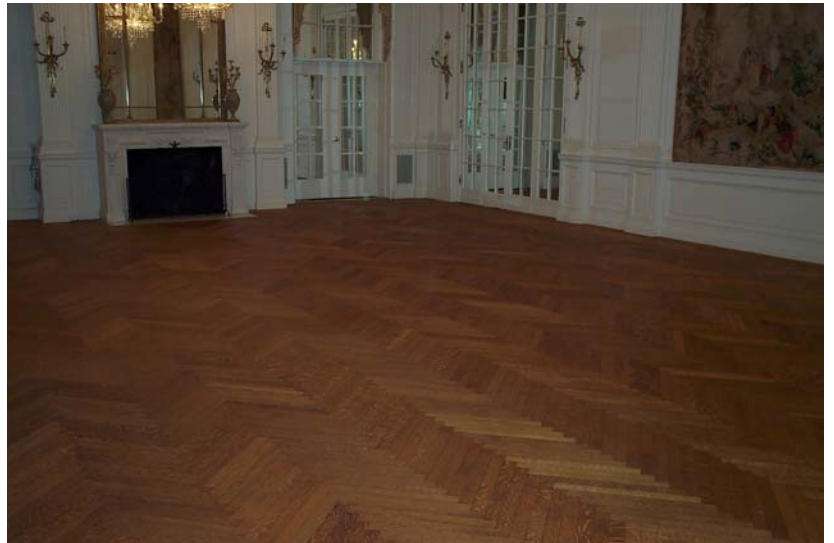
In this photo we see the ballroom floor after the restoration work was completed. The two photos here, the before and after, have not been altered in any way. The color tones of the 104 year old oak floors are the color achieved from aging. The rich color tones achieved here are the result of the wood making contact with an oil product.

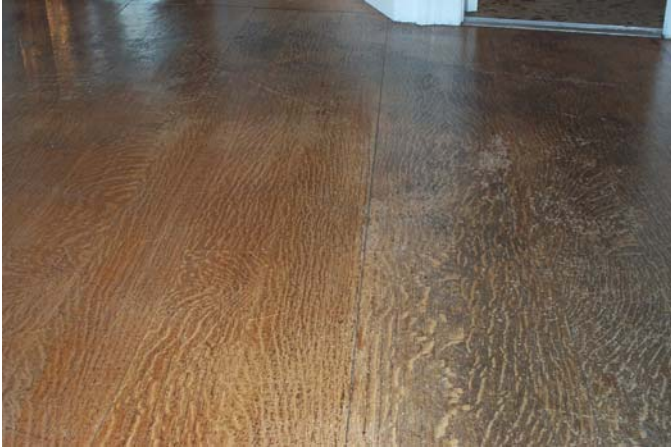
This photo was taken in the foyer in front of the French parlor doors leading into the ballroom. The right side of the photo shows the effect of acrylic maintenance products over an extended period of time. The darker color tones are due entirely to the maintenance products and how they age. The lighter section is where the wood was covered by the area rug.

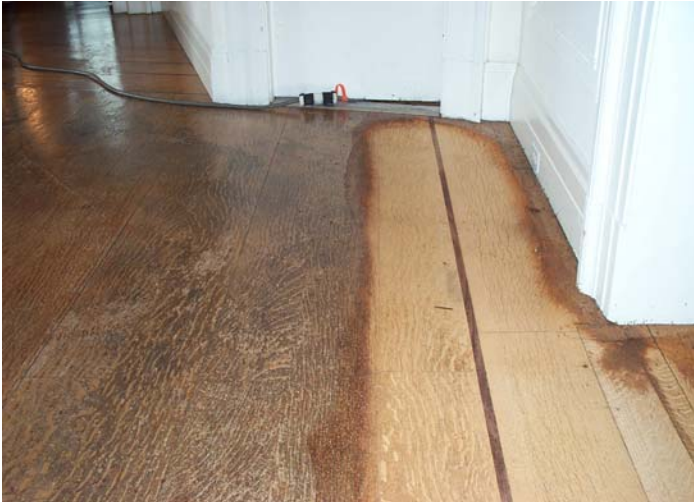
As the older coatings are removed we now see the bright white of the oak flooring. Fortunately it is not showing any adverse effects of the discolored finishes in front of the French doors. Note the contrast of the inlay strip of mahogany.

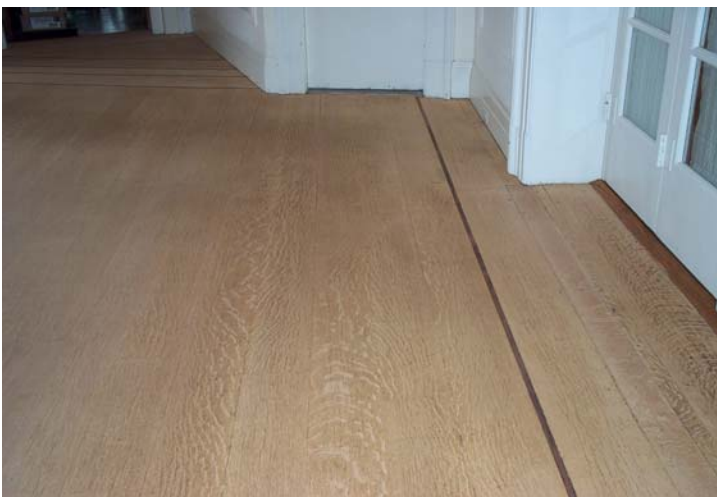
This third photo in the series shows the finish with all of the old finishes removed. Note that all the color variations in the old finish were not found in the wood. After the Trip Trap finish was applied, there were no visible traces of original discolorations.

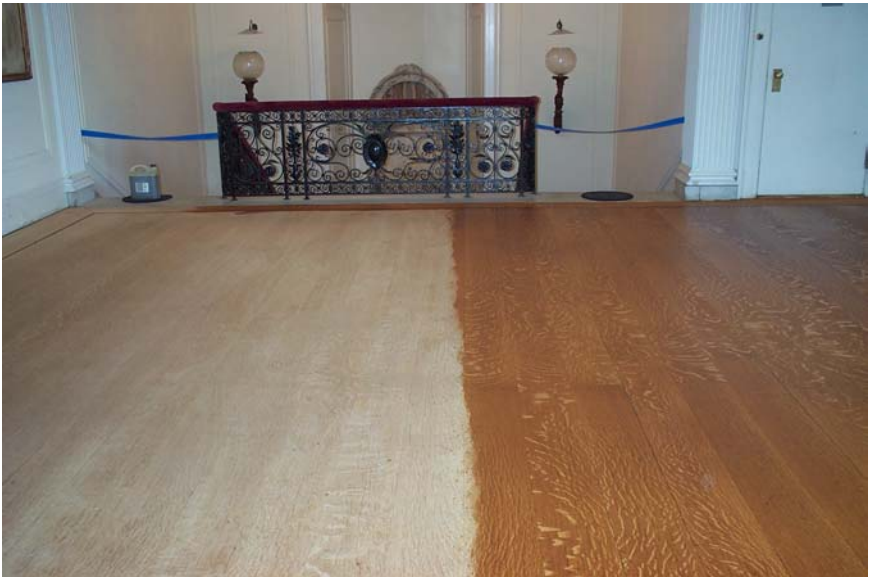
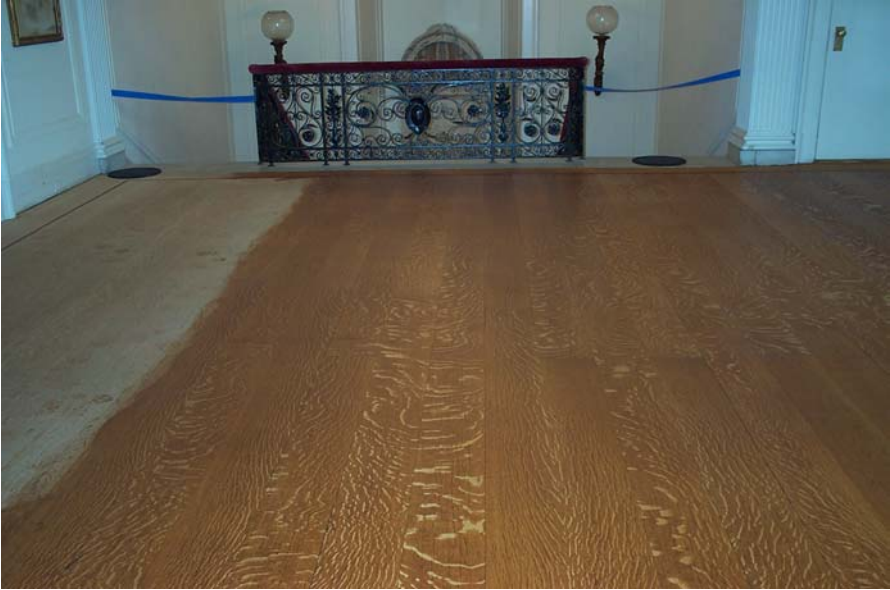
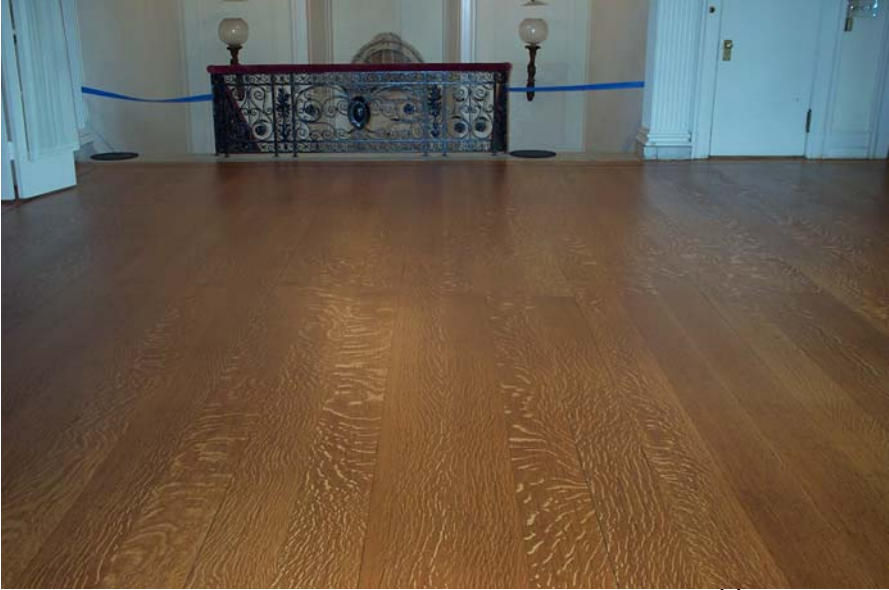
In this series of photos we see the progression of the finish as it is applied to the foyer floors. Please note the uniformity of color and the lack of distortion that was in the original finish prior to its removal.

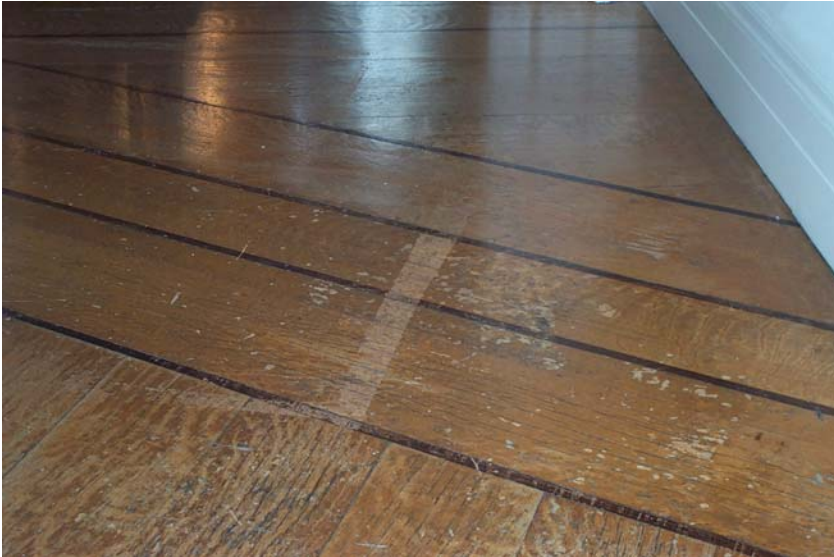
Finally we have the documentation of the removal of a source of frustration and embarrassment for members of the Patterson House Preservation Foundation. As noted previously, damage had occurred to the foyer floors outside the sitting room doors. The damage was apparent from the stripes left in the floor when masking tape was pulled up after an event. As the tape was pulled up, it removed several layers of old finish. The resulting contrast proved to be very visible and beyond repair.

Here we see the damaged area prior to any restoration work. Note the contrast.

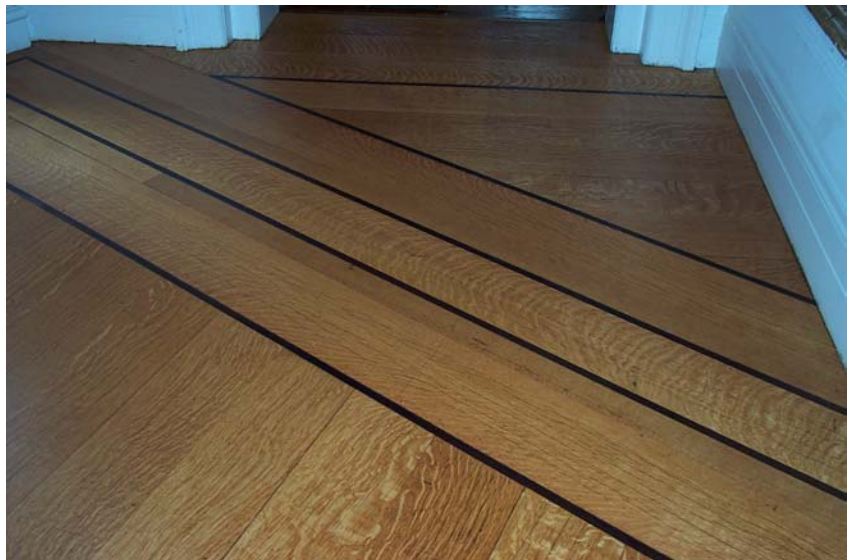
When work was completed, there were no visible color variations from the previous damage to the finish. By using an oil finish and products that do not result in the formation of any film forming products on the surface, we hope that this is the last of this particular problem.
