***A SUMMARY OF THE WOOD FLOOR
RESTORATION –
The Henry Morrison Flagler Museum
Whitehall***

***Palm Beach, Florida
September 1998 – June 2005***

Scope of the Restoration of the Wood Floors

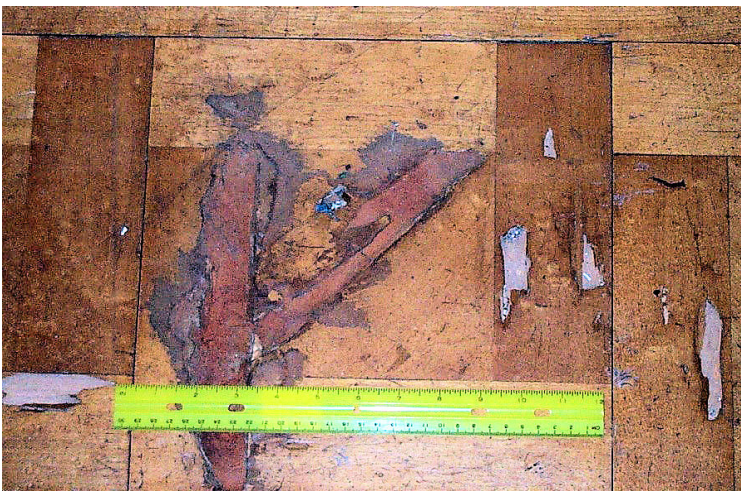
This photo is a good example of the type of termite damage to be resolved. This pattern was in the border of the French Parlor. The damaged cavities had been filled with wood filler from previous work.

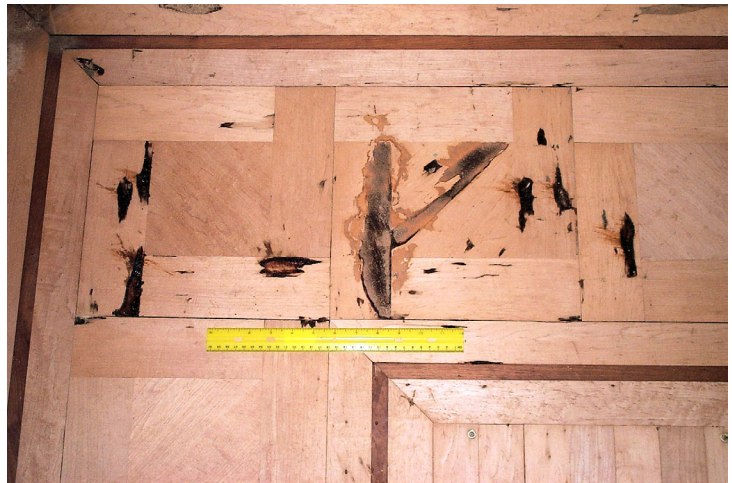
When the coatings were removed from the maple the termite damage was more visible. Coatings were always removed before any repair work started in order to inventory the scope of repairs needed..

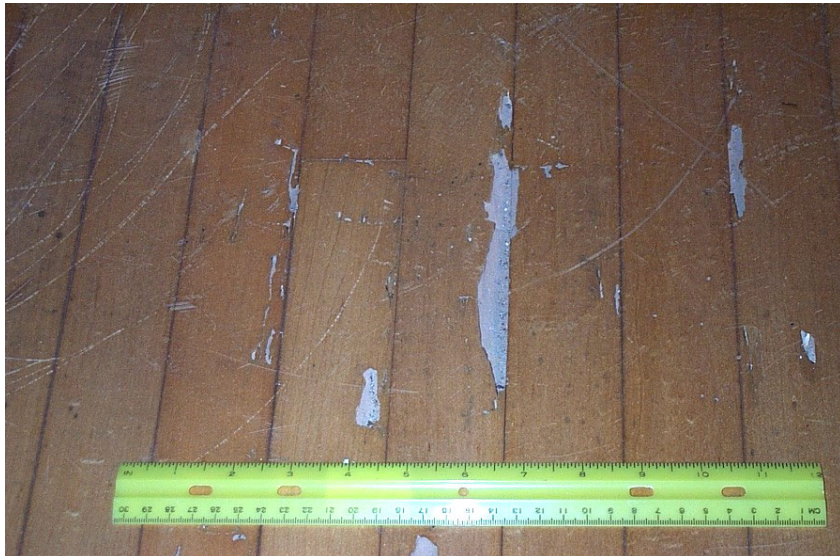
Another photo showing the damage as it appeared in the before stage. The lighter color is the wood filler (sheet rock mud) that had been forced into the cavity to repair the wood.

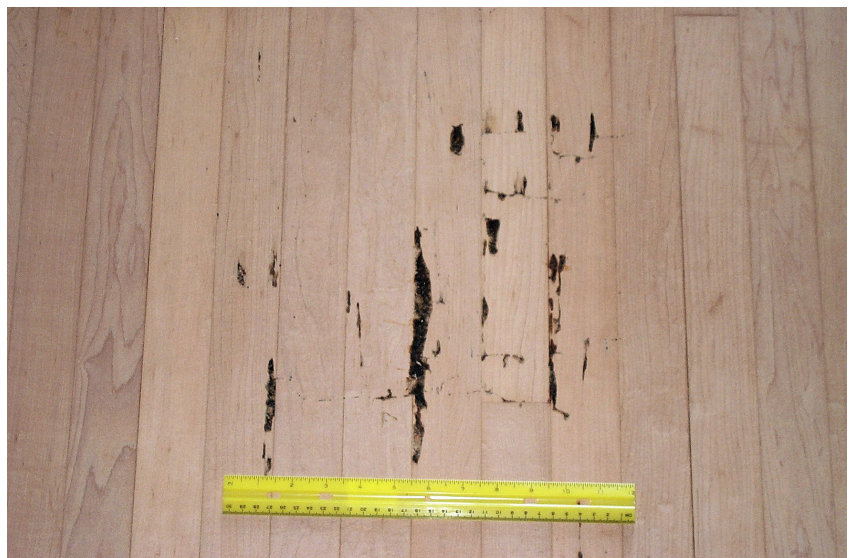
After the coating has been removed, the contrast reverses with the damaged areas being darker and the wood being lighter. This facilitated identifying the damaged pieces and defining the extent of repair needed.

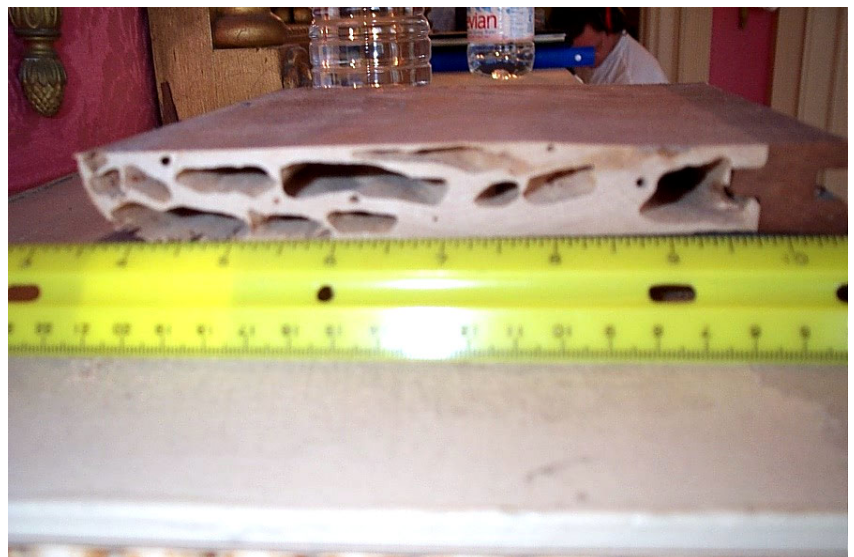
A side profile view of damaged wood removed along the border of the Colonial Room. Looking carefully at the top surface no damage is apparent. A side profile view tells the real truth of what was quietly going on!

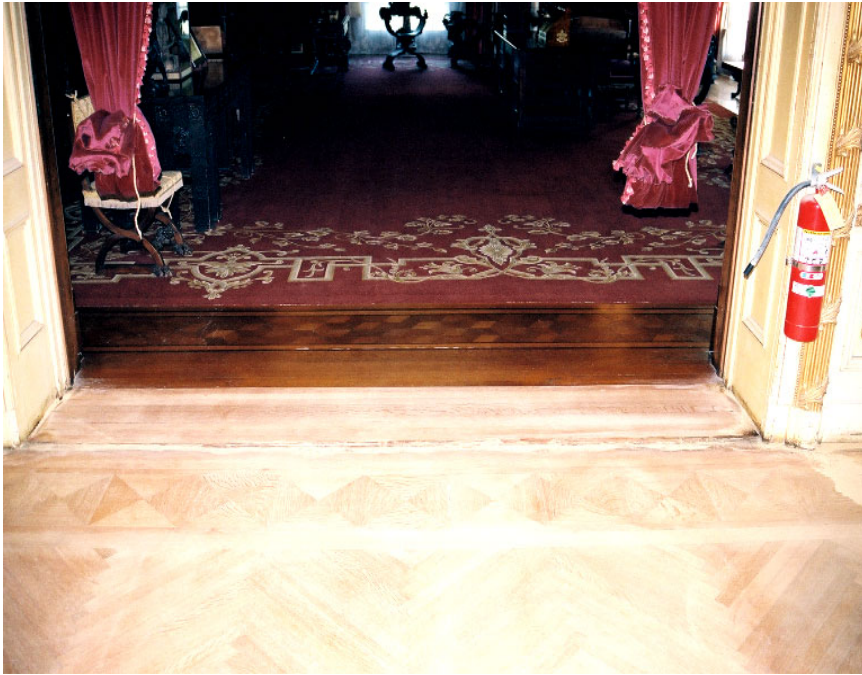
The proof of the dust containment is shown by the open door between the Music Room, where the work was going on, and the Library which was fully furnished. The door was left open while work was in progress.

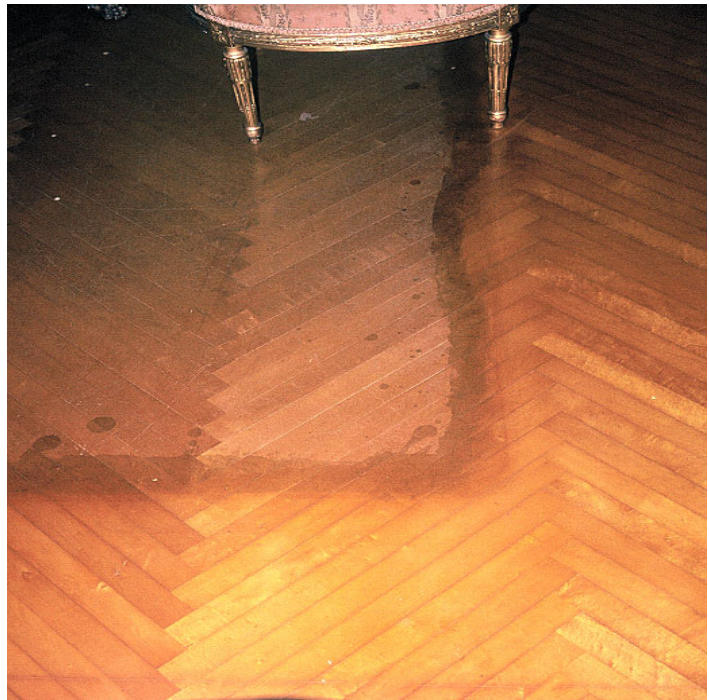
The darker outline here is where an area rug had been placed. The floors had been refinished around the rug. The lighter area, on the right side and bottom, were from finishes applied in 1960. The darker area in the upper left quadrant is the older finish that would most likely date back to the time Whitehall was converted to a hotel.

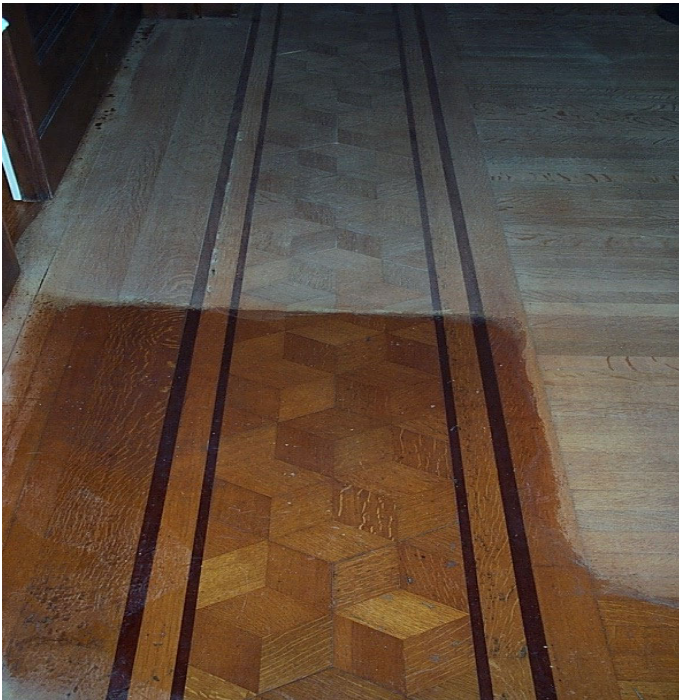
Here you see the results of the coatings coming off the oak floor in the Library. In the foreground is the old honey colored coating prior to its removal. In the background you see the bare quarter sawed white oak after coatings have been removed. No sanding was involved in the removal.

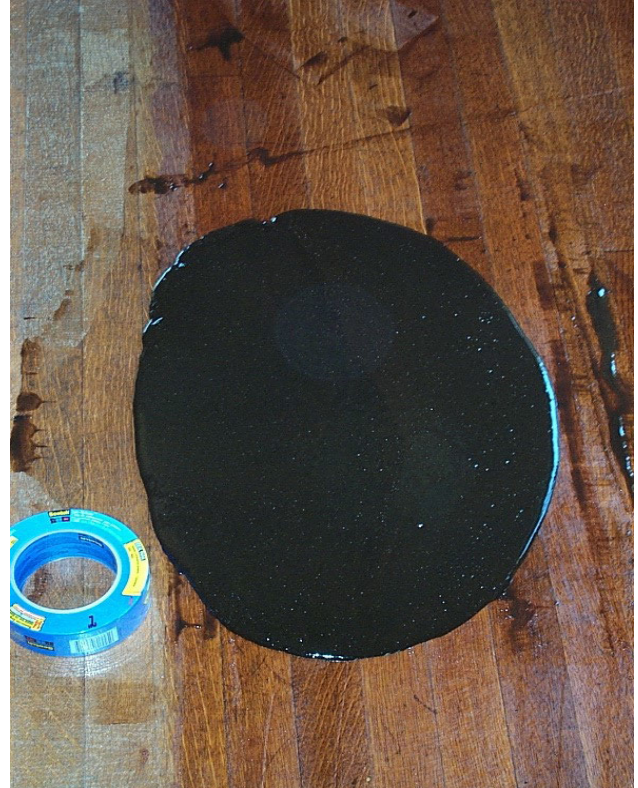
The black circular object in this image is the old honey colored finish after it has been put back into solution using the chemical cleaners. The honey background color around it is a result of the wood being wet. Once it dries out, it will assume the lighter color as the oak flooring seen above. It has been determined that the darkness of this pool is actually from the dirt that the old finish had accumulated over the years. The blue object is a roll of masking tape to help judge the dimensions of the pool.

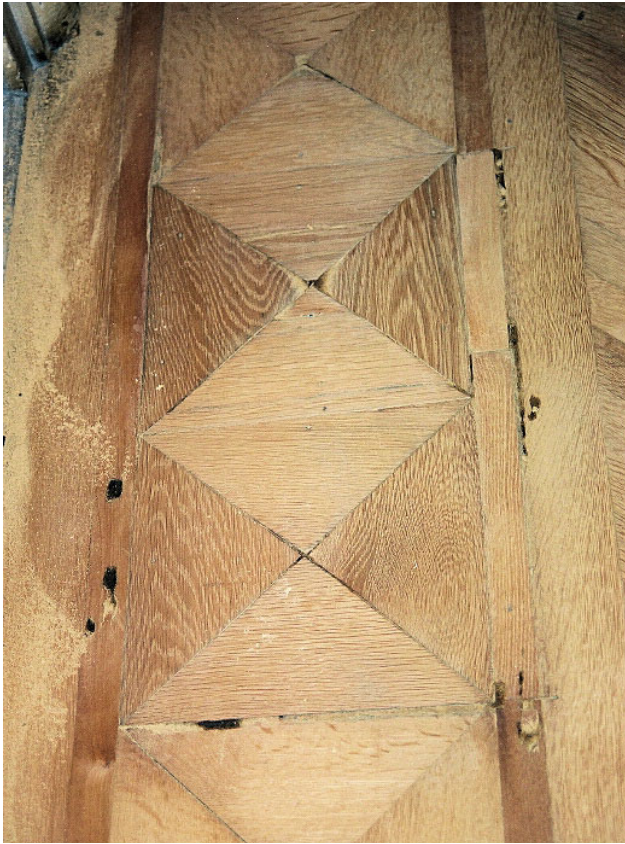
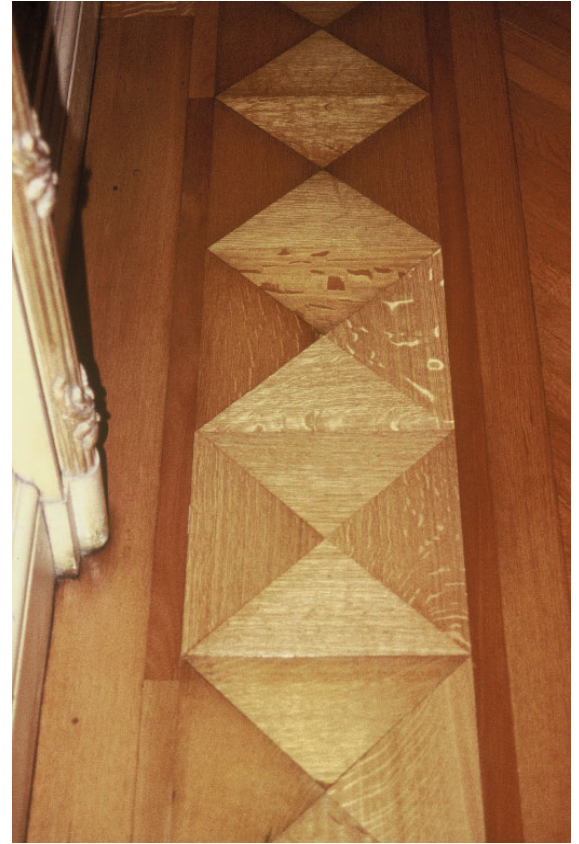
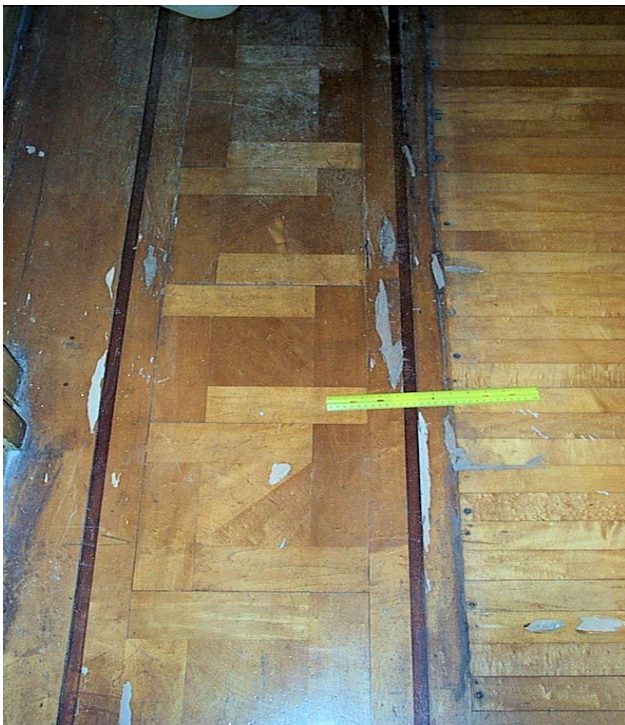
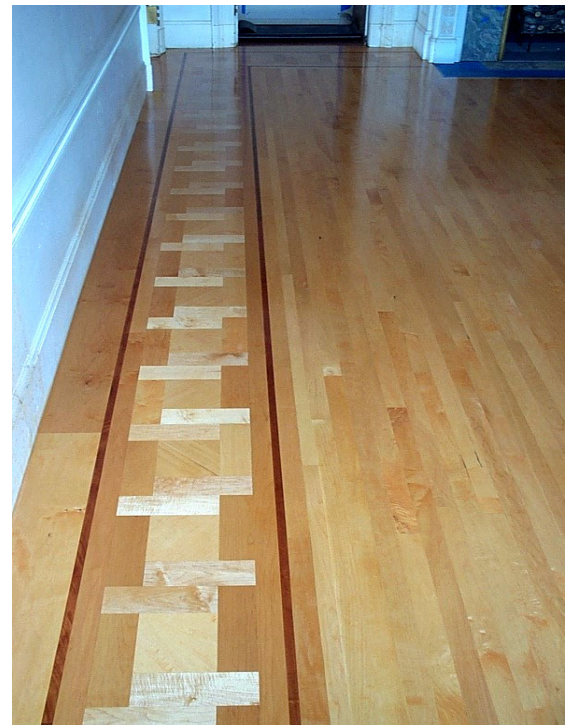
The remaining photos being presented are a collection of images that reflect the challenges faced, their resolution and a collection of “afters”.
