Wood Floor Restoration Summary
Patterson House – Washington, DC
Summer 2006

Rosebud Co.
Atlanta, Ga.

Overview and Explanation

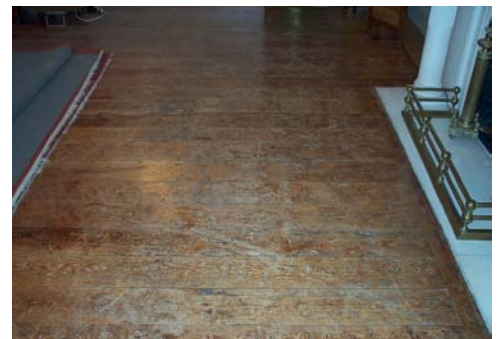
Before pictures of the pine floors in the Patterson Dining Room. Note lack of color and definition of distinguishing graining pattern.
