***THE RESTORATION
OF THE WOOD FLOORS OF
JAMES MADISON'S MONTPELIER***

June 2008
Rosebud Co.
Atlanta, GA

Overview & Summary of the Wood Floor Restoration

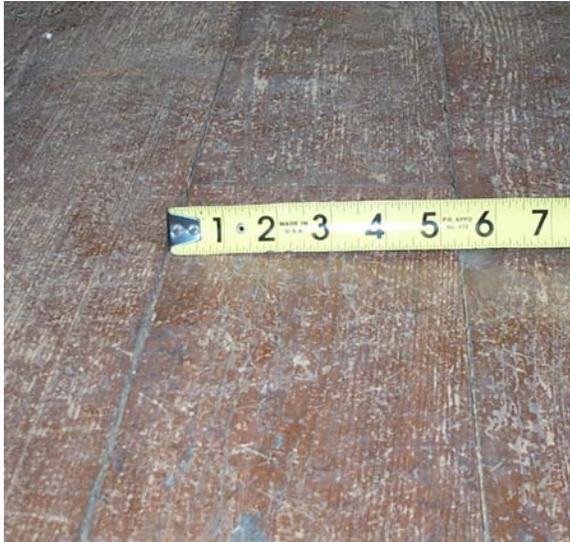
As you would expect with any 200 year old structure, many demands were placed on the wood floors of Montpelier. Initial dialogue on the restoration of the wood floors between Rosebud Co. and the Montpelier Foundation began in September of 2005. An onsite visit was made in May of 2008 to determine if Passive Refinishing was a viable option for the aged floors. The floors in question are on the first and second floor levels and consist of all the remaining original wood flooring from each of the three construction phases during the Madison era. Total square footage for the two levels is in excess of 6000 square feet. All additions and reconfigurations since the Madison's occupancy have been removed. Rooms have been reconfigured to the 1809 construction. Wood that had sustained enough damage to compromise the structural integrity was removed and replaced with like specie. The wood throughout the first and second floor is aged yellow pine. The majority of the wood is flat sawed with

generous amounts of quarter sawn in various areas. The most noticeable concentration of quarter sawn wood was in the entry vestibule and drawing room.

For a 200 year old floor, the wood was in remarkably good condition. There were layers of a variety of clear coatings and paints of various ages throughout the home. There did not appear to be any logical sequence or repeating color scheme in the selection of surface coatings. A comprehensive paint and coatings analysis of the surface coatings was

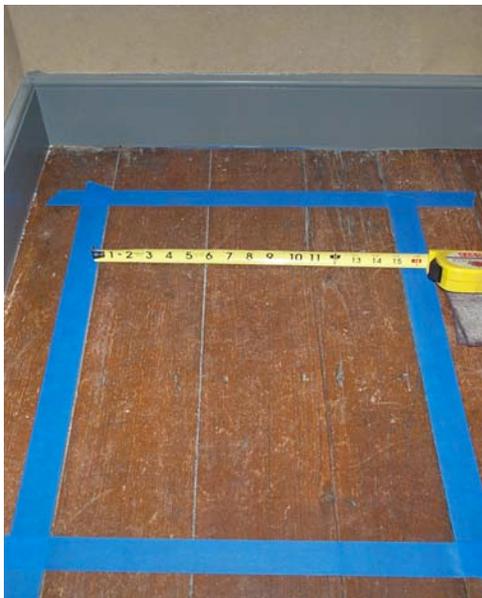
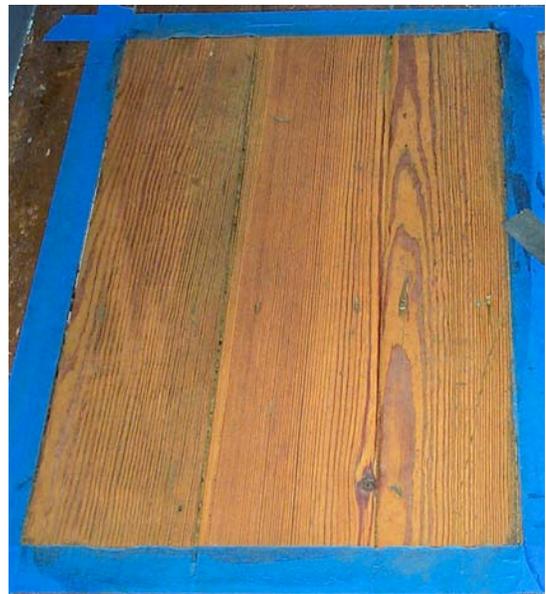
An onsite visit was made in May of 2008 for testing and sampling Passive Refinishing as a restoration option. The test site was on the second floor in a rear bedroom adjacent to the Madison's master bedroom. The following sequence shows the test area before (left) and after (right) the removal of the coatings.

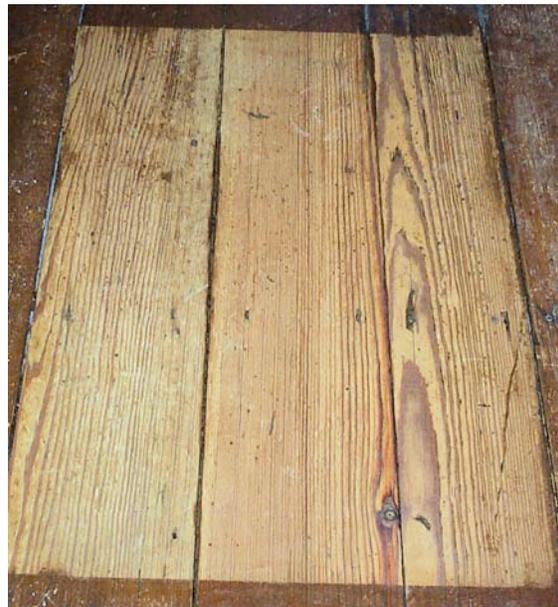
The sample was allowed to dry overnight and had a much lighter color with the loss of moisture the next morning. Graining is clean and crisp and the pattern of face nailing with the cut nails is visible in the center of the sample and run horizontally. Neither of these details was visible prior to cleaning.

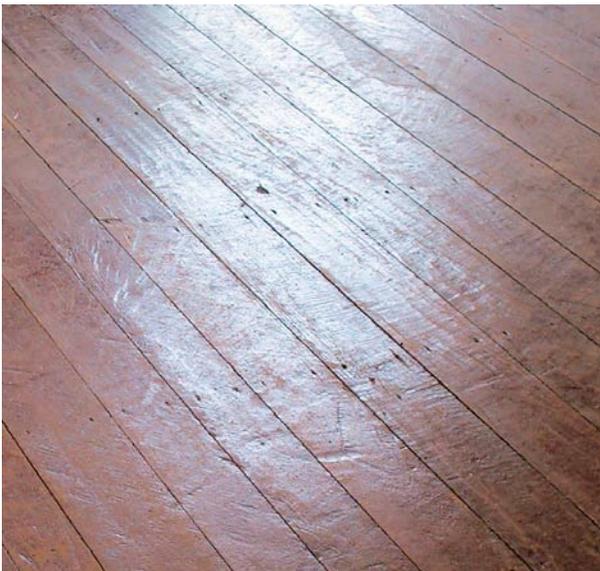
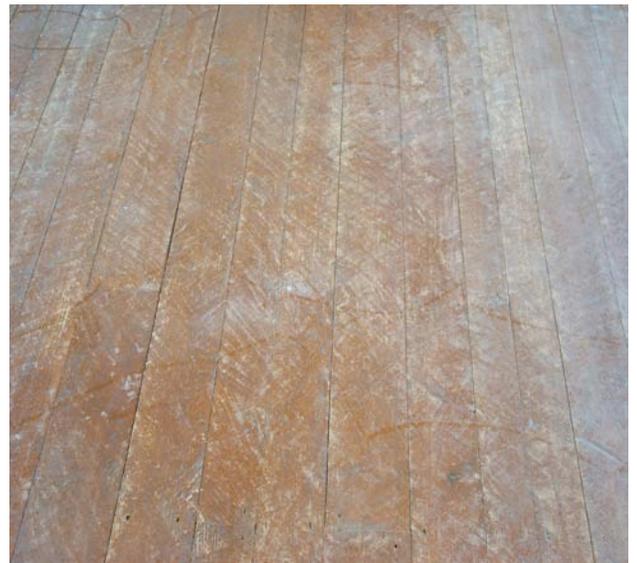
The condition of the floors in the master bedroom had created considerable concern as it appeared to have suffered the greatest loss of original material from an aggressive planing of the floor at some previous date. There is reason to believe that the floors had experienced water damage and were being leveled. The pictures below provide visual proof of the planing.

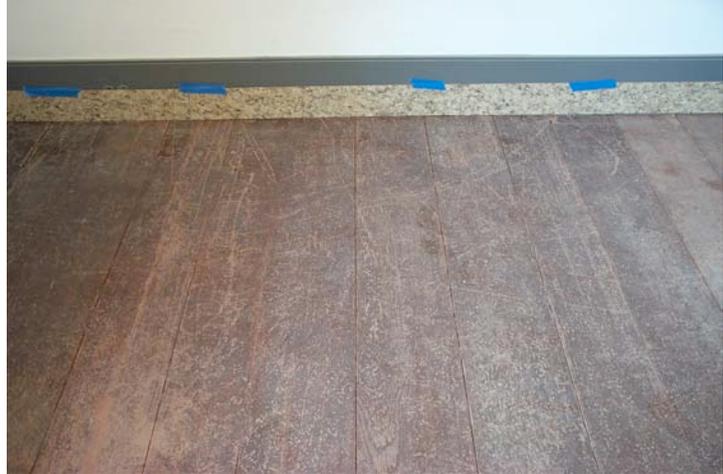
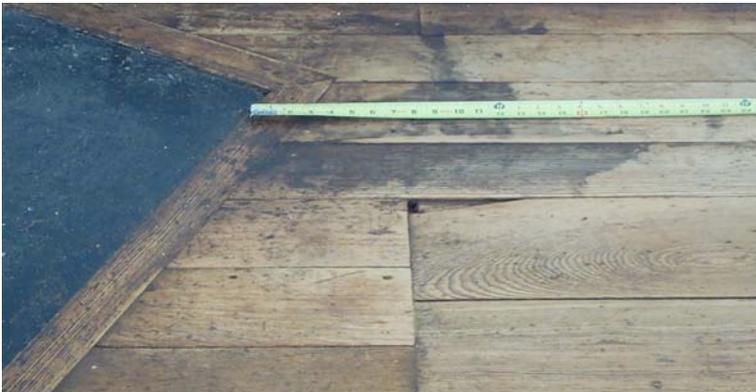
One of the most dramatic moments in the restoration work occurred on June 9th. Work had progressed to the second floor study. The study floors had one of the heaviest and darkest accumulations of surface coatings of any floor

in the entire home. A long rectangular room, it is centered behind the large front columns and provides a beautiful view of the Blue Ridge Mountains. Documents show that Madison spent considerable time in this room in his preparations for writing the Bill of Rights.

Work began along the long interior wall that interior wall stretched from a door going into the south second floor hallway and terminated into the fireplace that sits at an angle in the corner.

The first pass exposed staining in the floor that had the appearance of a liquid spill around the perimeter but did not appear to have a definitive pattern. As the work extended beyond the hearth by approximately 18 inches, there were numerous dark spots that have the unmistakable appearance and pattern of

drops of ink. Knowing the history of this room, the ink stains caused considerable excitement among workers and those managing the project. One cannot assume that the stains date to the Madison period but the use of the room and the presence of the stains only enhances the quality of the tour and interpretation. This discovery also set the stage for other revelations later in the project.

As I mentioned earlier, the discovery of the ink stains in the second floor study created some excitement. As the work moved to the downstairs area, work began in the downstairs study. This was the room adjacent to the dining room and was where Madison spent much of his late life. Arthritis prevented his navigating the stairs so Dolley had him moved into that room. It was here that Madison spent his time reviewing his notes and editing his papers. His reasoning was that this would be the most valuable asset he could leave

Dolley. And this is where we found an even more impressive ink stain than the one in the second floor study. We now are confronted with a tantalizing theory. The two rooms where it is documented that James Madison spent most of his time reading and writing are the two rooms that now display the largest collection of ink stains in the entire house. I will leave it to the reader to draw their conclusion but in my mind it is not asking too much of the imagination to conclude that Madison himself is responsible for these stains. Perhaps some day that can be confirmed.

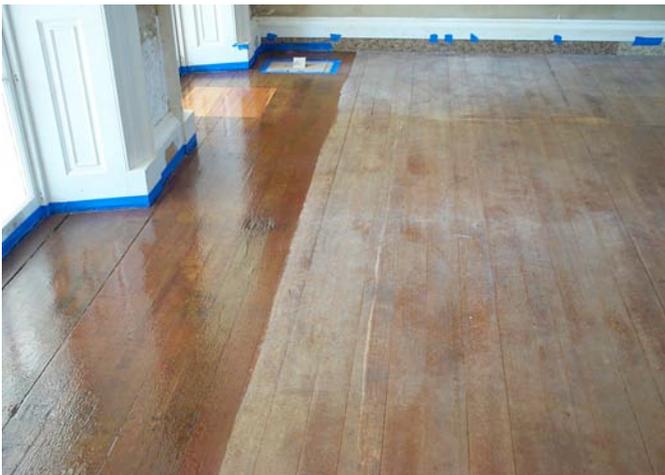
As the work progressed from the second floor to the downstairs rooms it became clear that Passive Refinishing was working as well or better than anticipated. Layers of old paint and varnish were being removed and the wood substrate was being left perfectly intact. This sequence of pictures shows the work in the Drawing Room and is typical of the progress we made and the results

achieved. You will notice a darker and shinier surface on the left of the photo. This is the cleaner after it is applied and before it is removed. The flooring to the right is the “before” condition we found when the protective covering was removed.

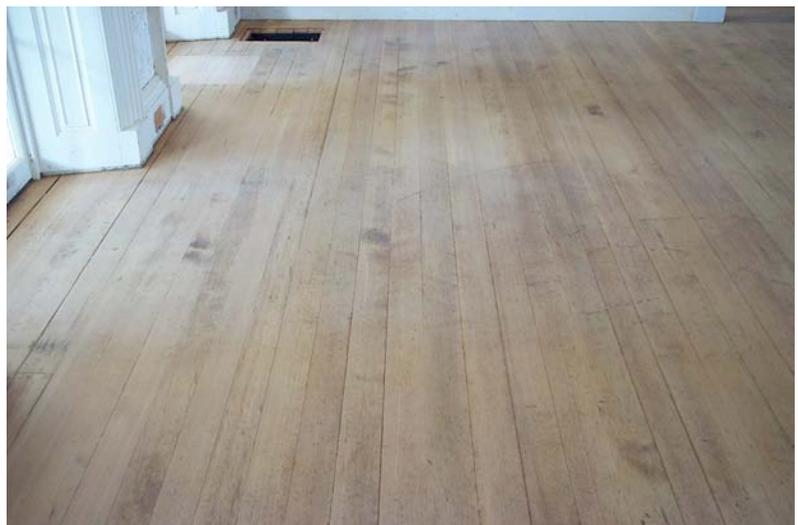
From the same vantage point we see the floor after the layers of old coatings have been removed. The amber color of the old finish is gone and the wood is exposed for the first time in many, many years.

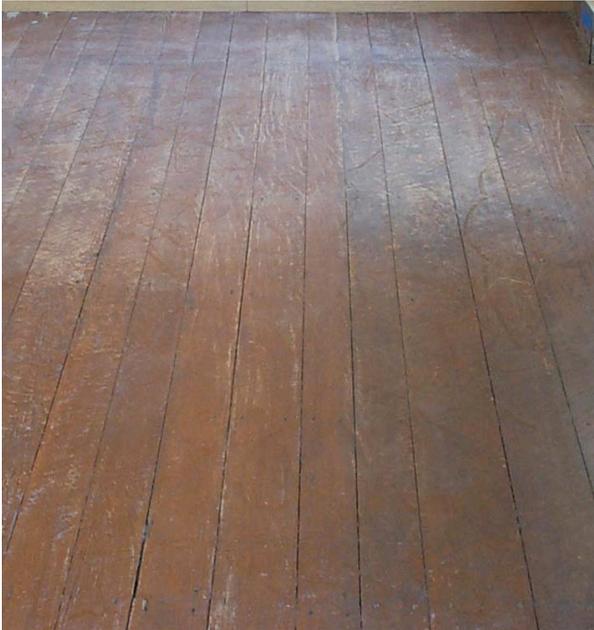
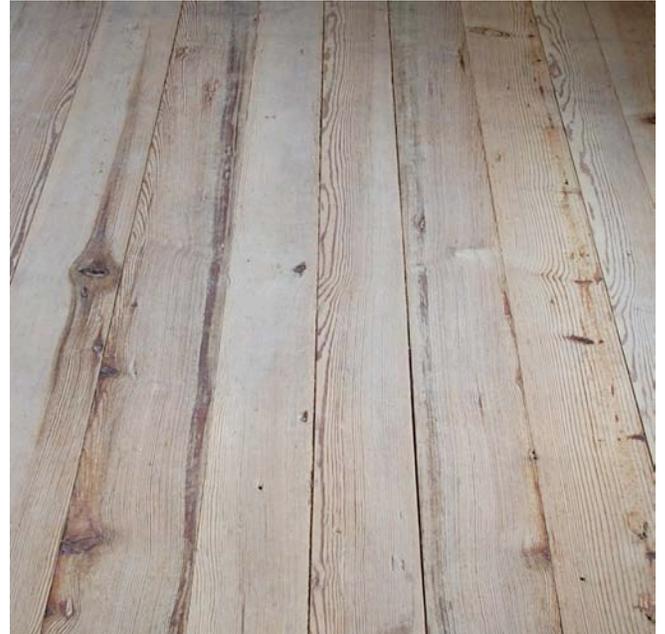
A final comparison of the restored wood shows a more dramatic contrast of before and after. The stark color of the wood minus the build up of coatings is an excellent example of how wood ages in the interior of old homes. It is also very likely to have been the look that James and Dolley Madison would have seen.
